Report No. CETHA-BC-CR-89049

## Task Order 2 Enhanced Preliminary Assessment

DEFENSE MAPPING AGENCY (DMA)  
HERNDON, VIRGINIA

December 1989

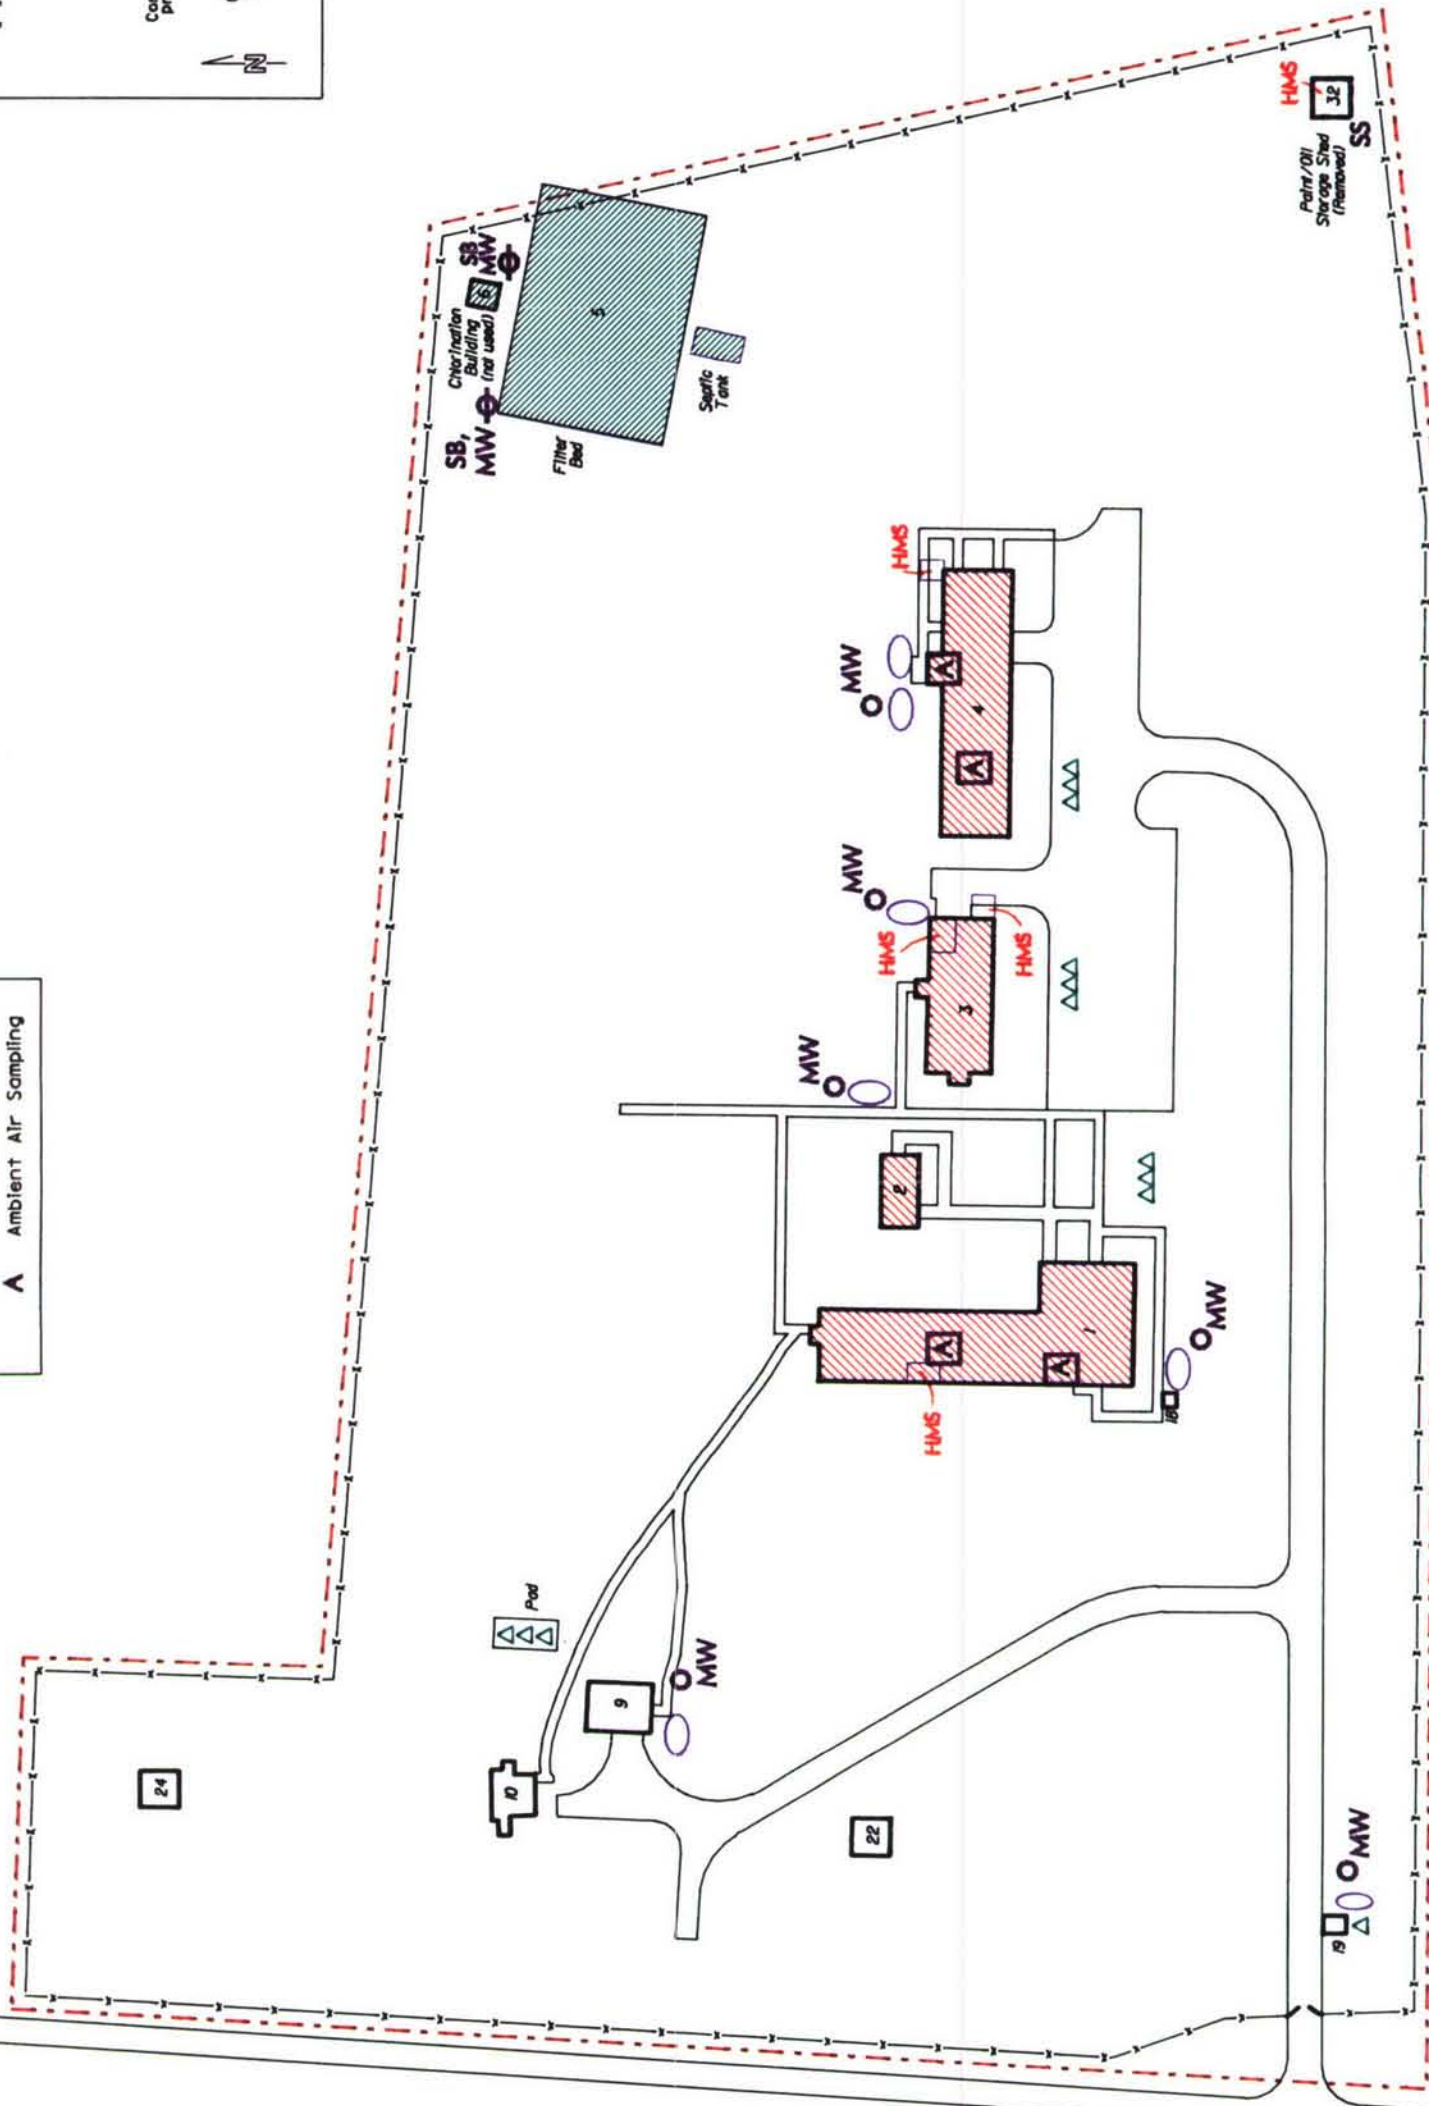
- Underground Storage Tanks: Seven tanks, three active (used for storing gasoline and fuel oil) and four inactive (pumped out and filled with concrete). Two of the inactive tanks could not be successfully leak tested prior to being closed and may have released fuel oil to the surrounding soils and/or groundwater. Monitor wells have been installed near all tanks. No sampling has been conducted to date.

- Asbestos in Structures: Pipe insulation, floor tiles, and other materials in the four main buildings onsite have been tested and found to contain asbestos. Asbestos materials appear in good condition.

No environmental conditions were observed on the DMA property that appear to present an immediate substantial threat to human health or the environment. However, the ESOs discussed in Section 3 have the potential to affect human health or the environment. The recommendations concerning each item follow and are summarized in Table ES-1. Recommended sampling locations are shown in Figure ES-1.

The former paint/oil storage shed could have been a source for a release of hazardous materials to the environment. Surface soil samples should be taken in the area after the location of the shed has been determined.

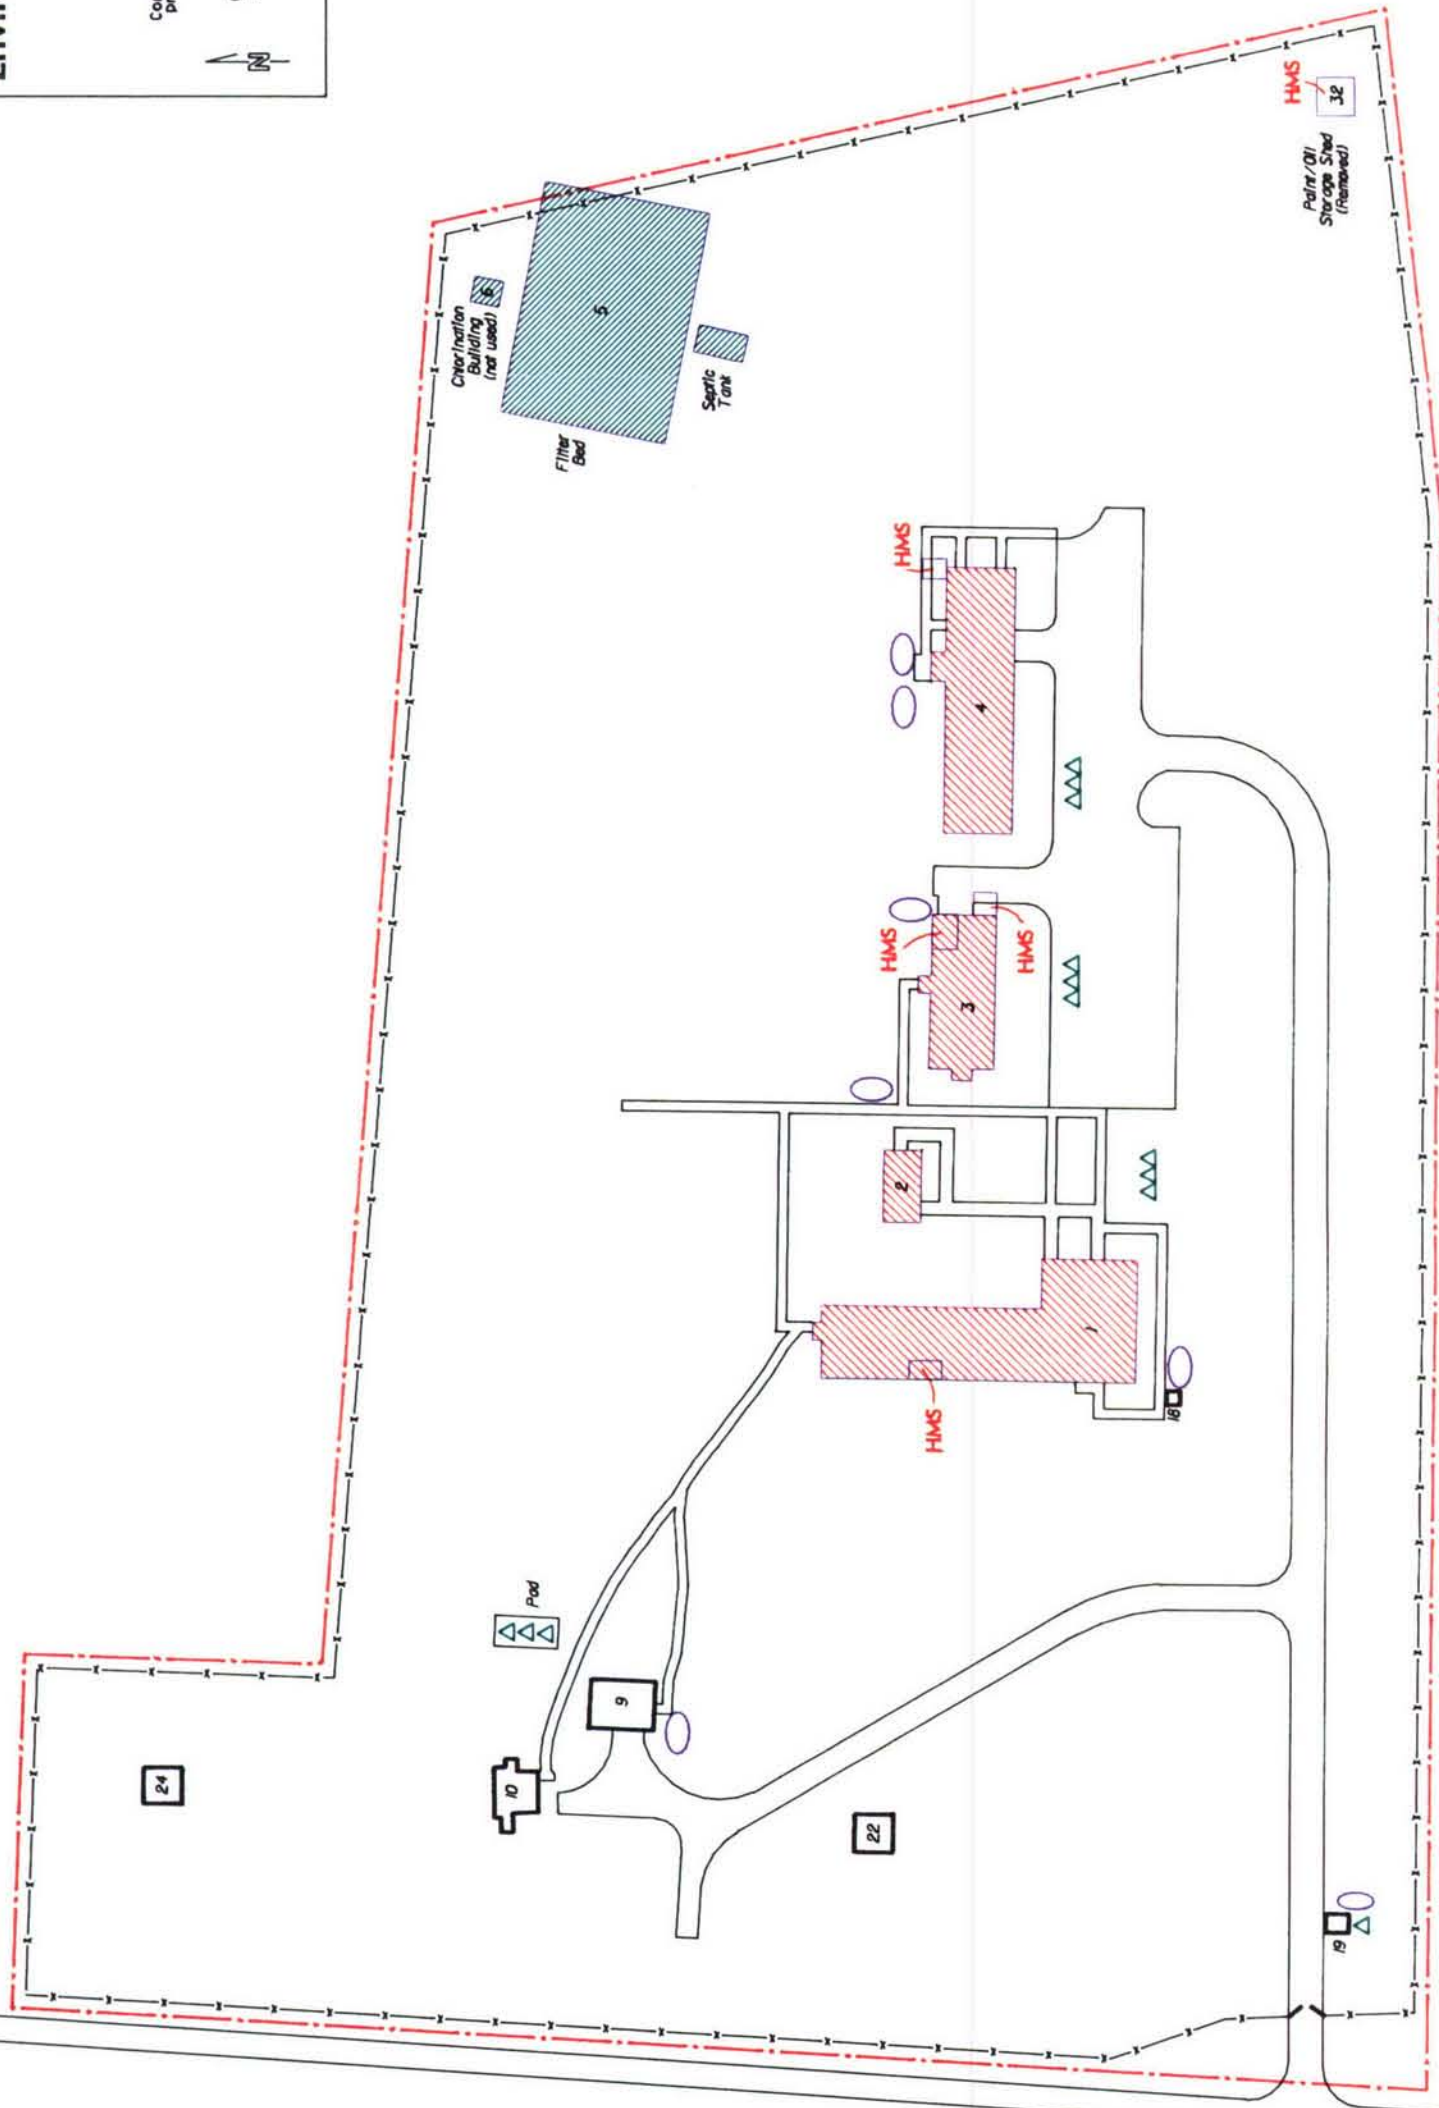
**ENVIRONMENTALLY SIGNIFICANT OPERATIONS**

- Underground Storage Tanks
- Septic System
- Building With Asbestos-containing Material
- Transformer
- HMS Hazardous Materials Storage

The two tanks at Buildings 3 and 4 could not be effectively leak tested and there was some breakage or corrosion associated with the fill pipes. Accordingly, there is a possibility that underground storage tanks on the facility may have released some of their contents to soils.
